**Name Of Dam:** SOUTH RIVER NO. 11

**Location:** AUGUSTA COUNTY, STATE OF VIRGINIA

**Inventory Number:** VA 01512

# PHASE I INSPECTION REPORT

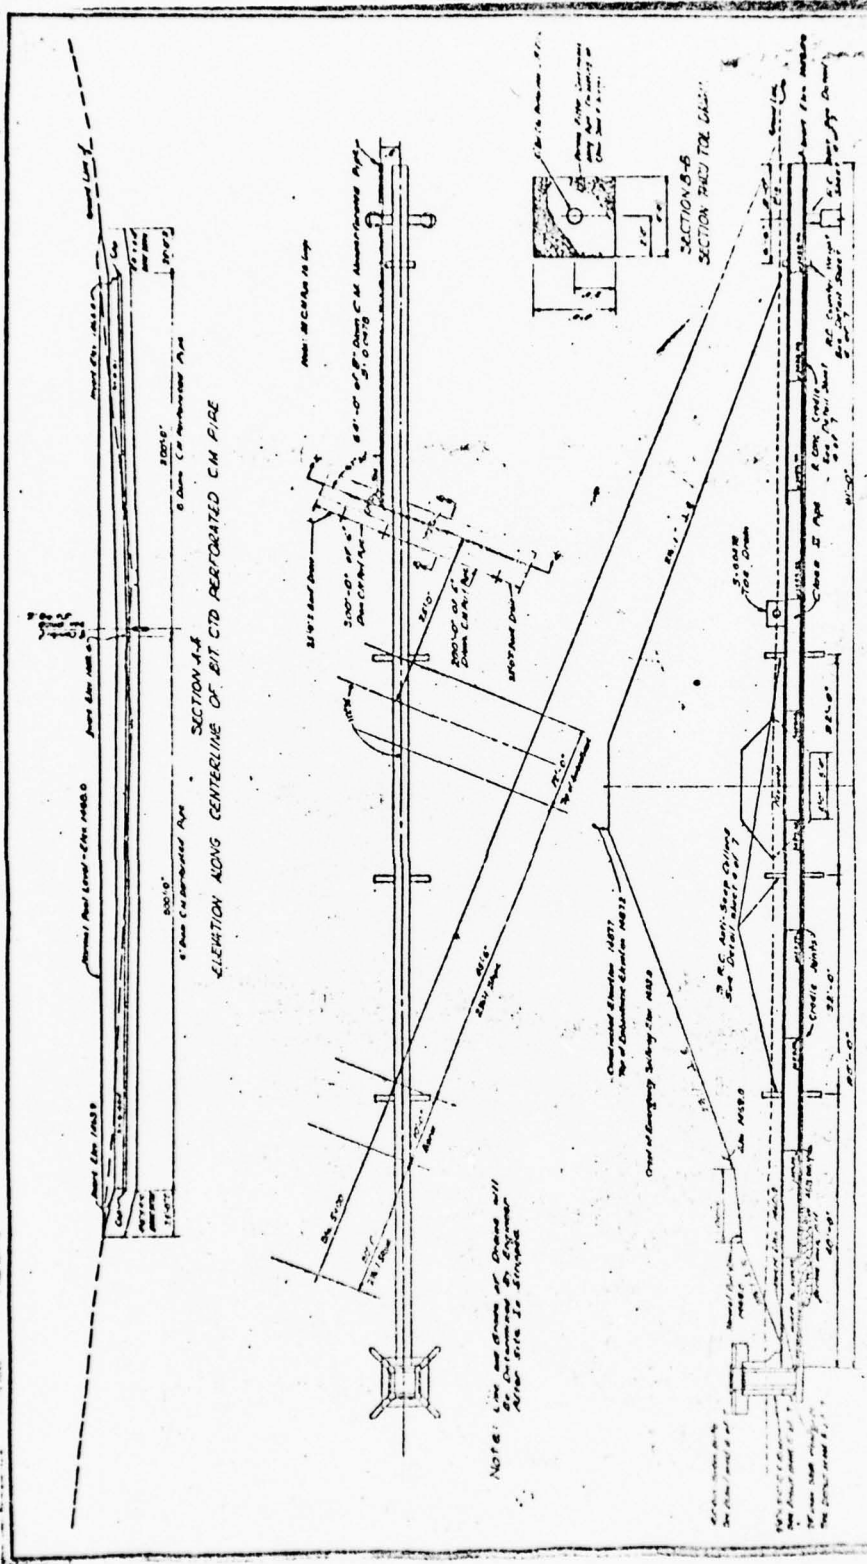
PLATE 3

The principal spillway consists of a reinforced concrete riser (see Photo 1) with a 24 inch concrete pipe as a discharge conduit (see Photo 2). The discharge is controlled by a drop-inlet at the crest of the riser (elevation 1468.0 feet). The reservoir may be drained by the use of a hand-operated 24 inch slide gate. A typical section through the principal spillway is shown on Plate 3.

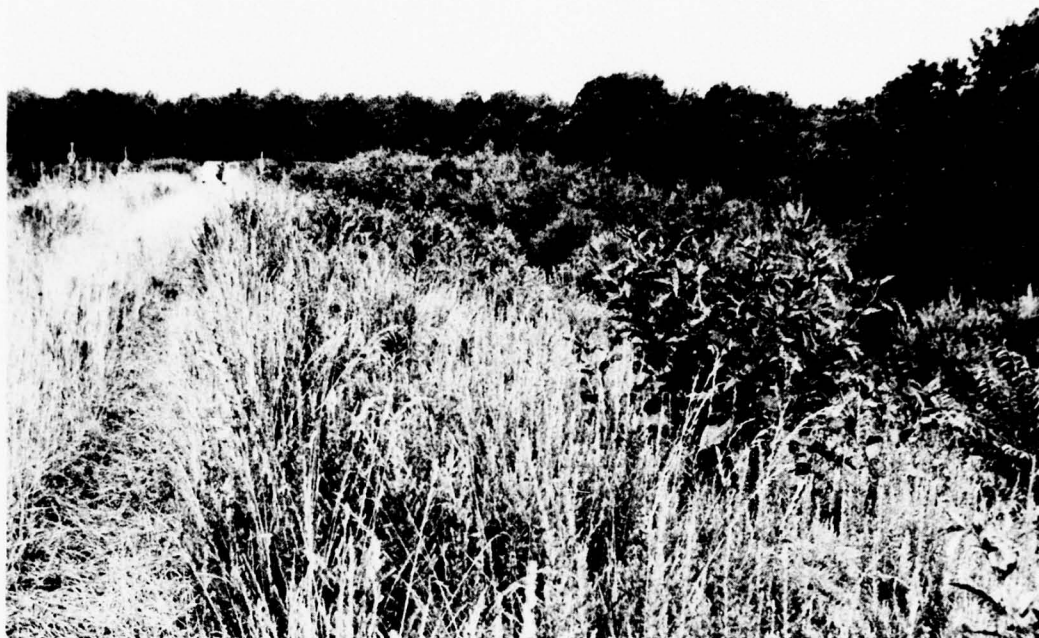
- 3.1.2 Dam: No seeping or sloughing was observed during the inspection. A few, eroded, pedestrian paths are present on both the upstream and downstream faces of the dam. Also, small trees and thick brush were noted growing on the embankment (see Photos 3 and 4).

**PHOTO 3. Brush and Trees Growing on Downstream Face Looking From Right Side**

- 1) The brush and small trees growing on the embankment and in the emergency spillway should be removed.

- 1) Cut and remove the brush and small trees from both faces of the dam and the emergency spillway.
- 2) Fill and reseed the eroded foot paths.
- 3) Periodically clean and paint the trash rack to prevent corrosion.
- 4) Periodically clear the banks of the downstream channel to prevent obstruction of flow.

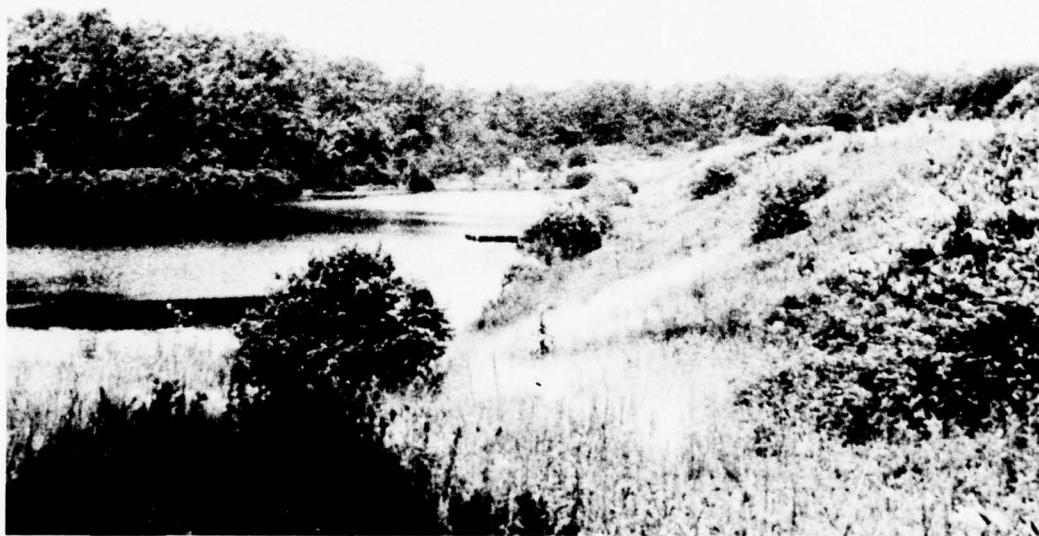
**PHOTO 4. Brush and Trees on the Upstream Face Looking From Right Side**
